# **INDOOR AIR QUALITY ASSESSMENT**

**Division of Fisheries and Wildlife  
Field Headquarters  
1 Rabbit Hill Road  
Westborough, MA**

Prepared by:  
Massachusetts Department of Public Health  
Center for Environmental Health  
Emergency Response/Indoor Air Quality Program  
May 2007

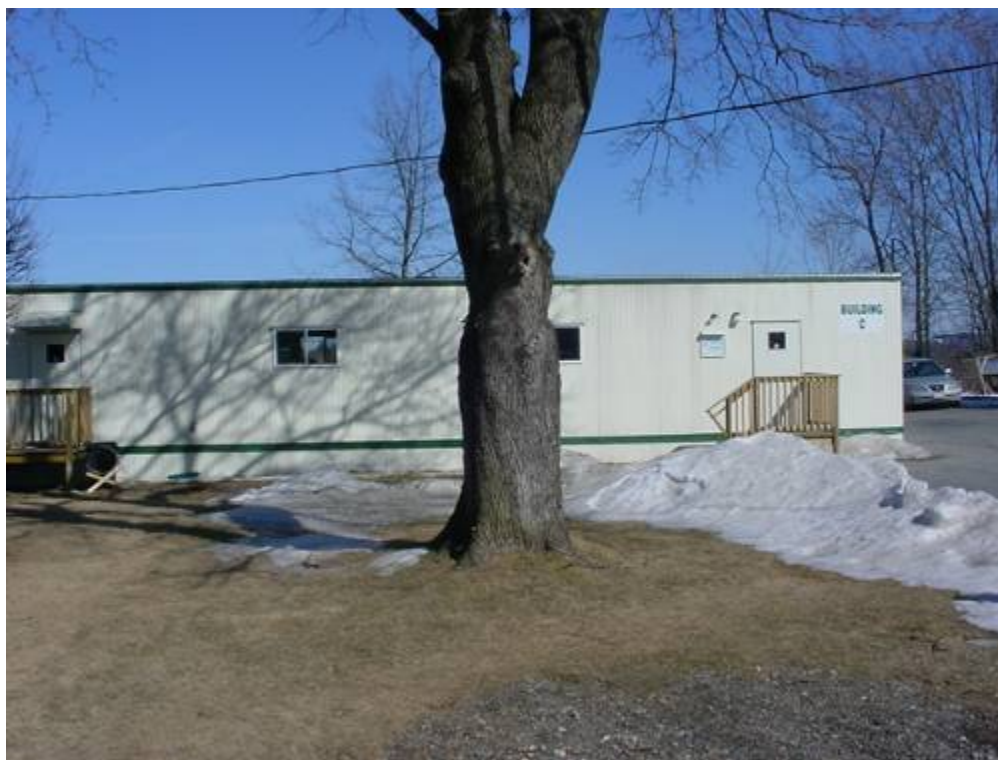
**Picture 1**

**Modular Office Unit Building C**

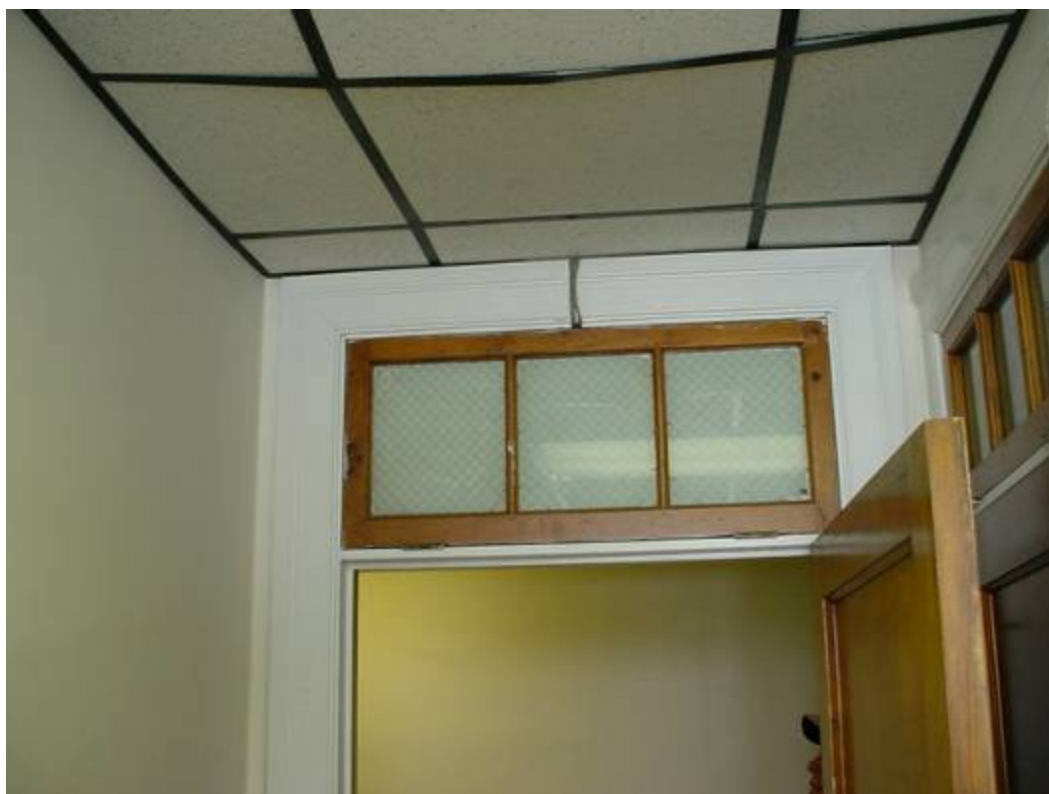
**Picture 2**

The building was originally designed to use openable windows on opposing exterior walls to create cross-ventilation and provide comfort for building occupants. In addition to openable windows, the building has hinged windows located above hallway doors. These hinged windows or transoms (Picture 2) enable occupants to close hallway doors while maintaining a pathway for airflow into the rooms. This design allows for airflow to enter an open window, pass through a room, pass through the open transom, enter the hallway, pass through the opposing open room transom and exit the building on the leeward side (opposite the windward side) ([Figure 1](#)). With all windows and transoms open, airflow can be maintained in a building regardless of the direction of the wind. This system fails if the windows or transoms are closed ([Figure 2](#)). Most transoms were found closed and/or permanently sealed at the time of the assessment.

**Sealed Transom above Hallway Door**

3. Open windows to temper rooms and provide fresh air in Building A. As discussed, this building was designed to use windows (in combination with radiators) to provide fresh air and heat. Care should be taken to ensure windows are properly closed at night and weekends to avoid the freezing of pipes and potential flooding.

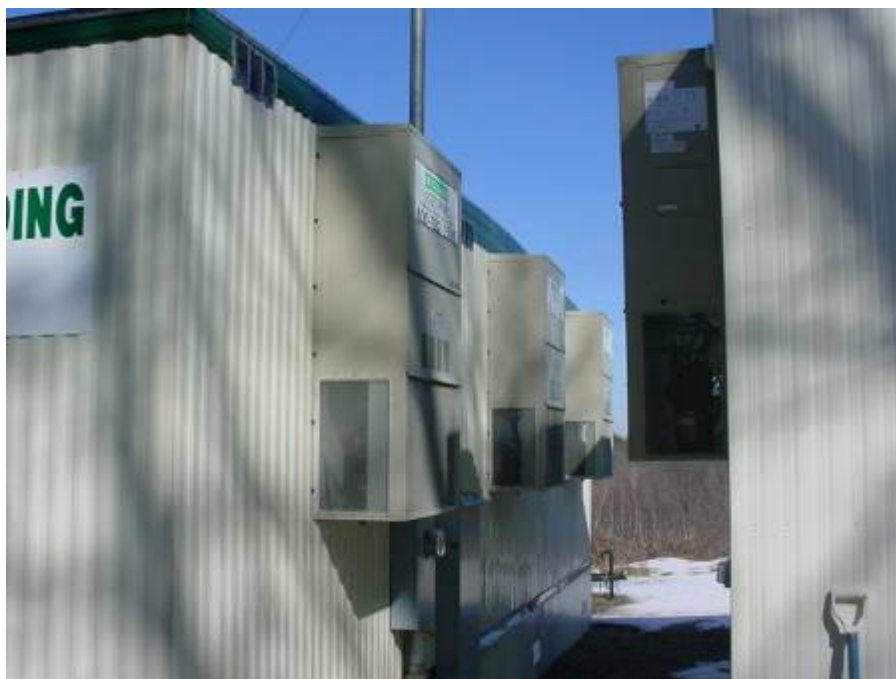
**Picture 3**

(AHUs) mounted on the exterior of the buildings (Picture 3). Fresh air is distributed via ductwork connected to ceiling-mounted air diffusers and drawn back to the AHUs through return grilles. Thermostats control each heating, ventilating and air conditioning (HVAC) system and have fan settings of “on” and “automatic”. Thermostats were set to the “automatic” setting (Picture 4) during the assessment. The automatic setting on the thermostat activates the HVAC system at a preset temperature. Once the preset temperature is reached, the HVAC system is deactivated. Therefore, no mechanical ventilation is provided until the thermostat re-activates the system. It is important to note that the assessment was conducted on an extremely cold day (<32 °F). During these types of temperature extremes, fresh air drawn into the heating, ventilating and air-conditioning (HVAC) system is often reduced to prevent freezing/damage of HVAC system components. Limiting fresh air intake either by mechanical and/or natural means (e.g., closing of windows) can contribute to an increase in carbon dioxide levels indicating a lack of fresh air to occupied spaces.

**AHUs Mounted on the Exterior of Modular Office Buildings**

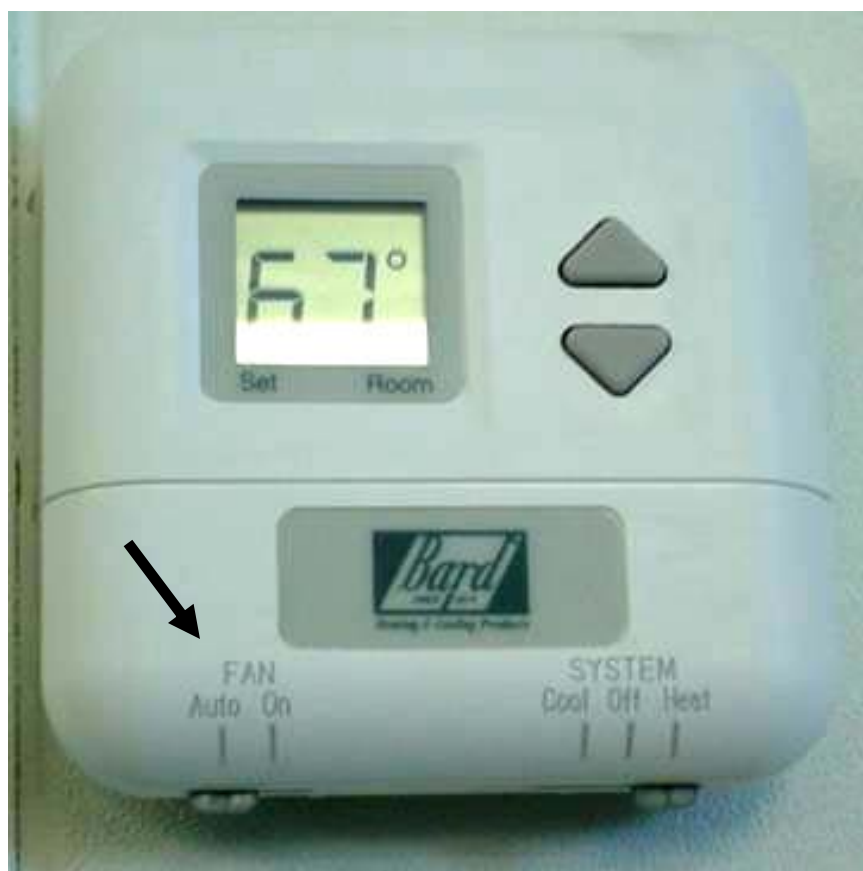
**Picture 4**

**Thermostat in Modular Office Building with Fan Set to “Auto”**

5. Operate thermostats for modular offices (Buildings B and C) in the fan “on” setting during occupancy to provide continuous air circulation.
6. Consider adopting a balancing schedule of every 5 years for mechanical ventilation systems, as recommended by ventilation industrial standards (SMACNA, 1994).

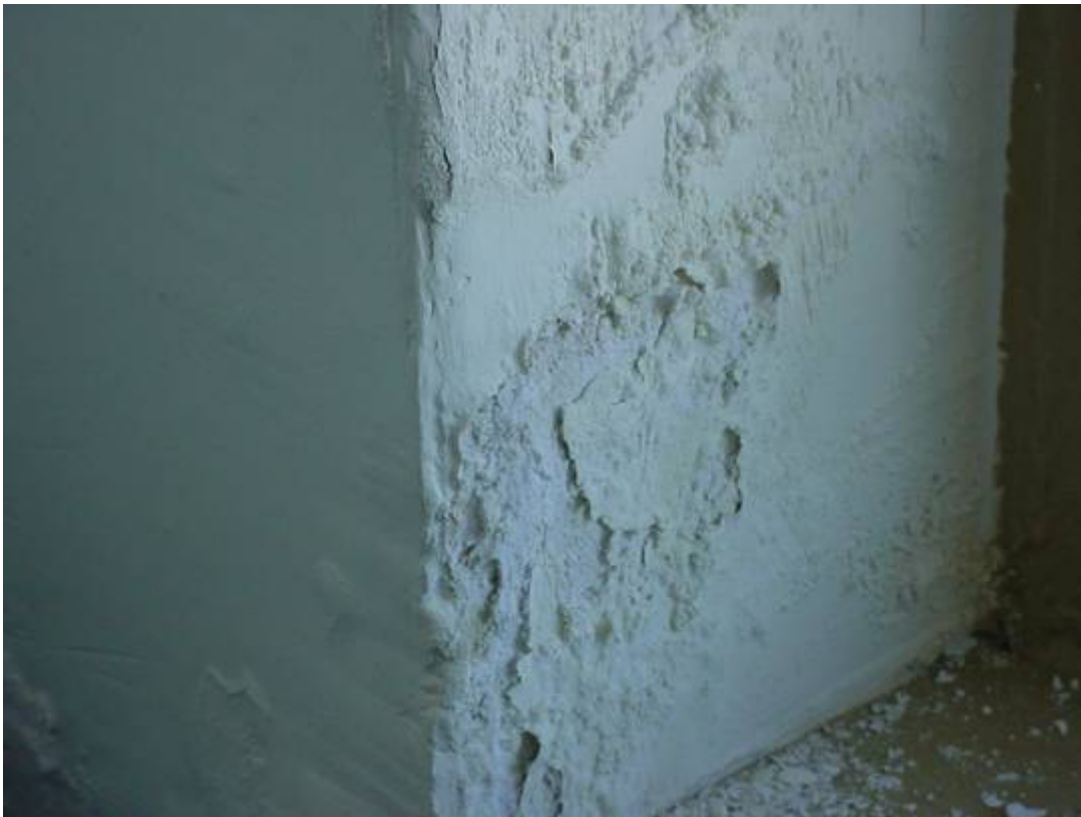
**Picture 5**

Building A reportedly has a history of water infiltrating through the building envelope. CEH staff observed water stained ceiling tiles, damaged wall plaster, peeling paint and efflorescence on ceilings and walls in a number of areas (Table 1/Pictures 5 to 9). Repeated water damage to porous building materials can lead to mold growth. Dark staining which appeared to be mold growth was observed on a ceiling tile and gypsum wallboard (GW) in the basement (Pictures 8 and 9). Efflorescence is a characteristic sign of water damage to brick and mortar, but it is not mold growth. As moisture penetrates and works its way through mortar and brick, water-soluble compounds in mortar and brick dissolve, creating a solution. As the solution moves to the surface of the mortar or brick, the water evaporates, leaving behind white, powdery mineral deposits. According to Mr. Deblinger, plans to re-point the building are scheduled for spring of 2007. Re-pointing of the buildings façade should eliminate sources of water penetration through the exterior wall.

**Water Damaged Wall Plaster/Efflorescence and Peeling Paint**

1. Continue with plans to have exterior of the building re-pointed to prevent further water penetration and damage to building materials.
2. Remove water damaged/mold-colonized building materials (e.g., GW) in areas that are susceptible to water penetration. Mold-colonized materials should be remediated in a manner consistent with recommendations in “Mold Remediation in Schools and Commercial Buildings” published by the US Environmental Protection Agency (US EPA, 2001). This document is available from the US EPA website:  
[http://www.epa.gov/iaq/molds/mold\\_remediation.html](http://www.epa.gov/iaq/molds/mold_remediation.html).

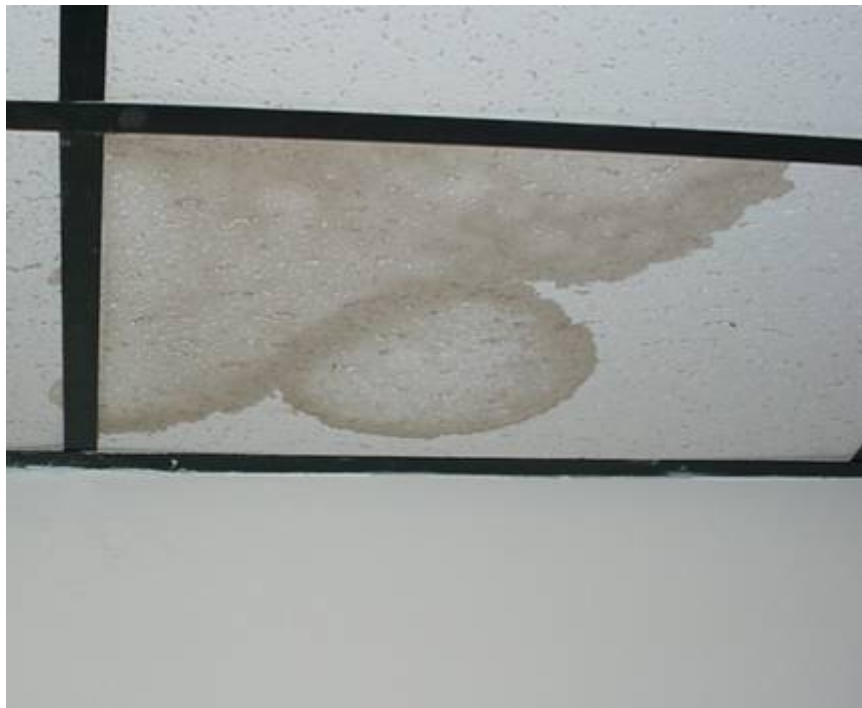
**Picture 6**

**Water Stained Ceiling Tiles**

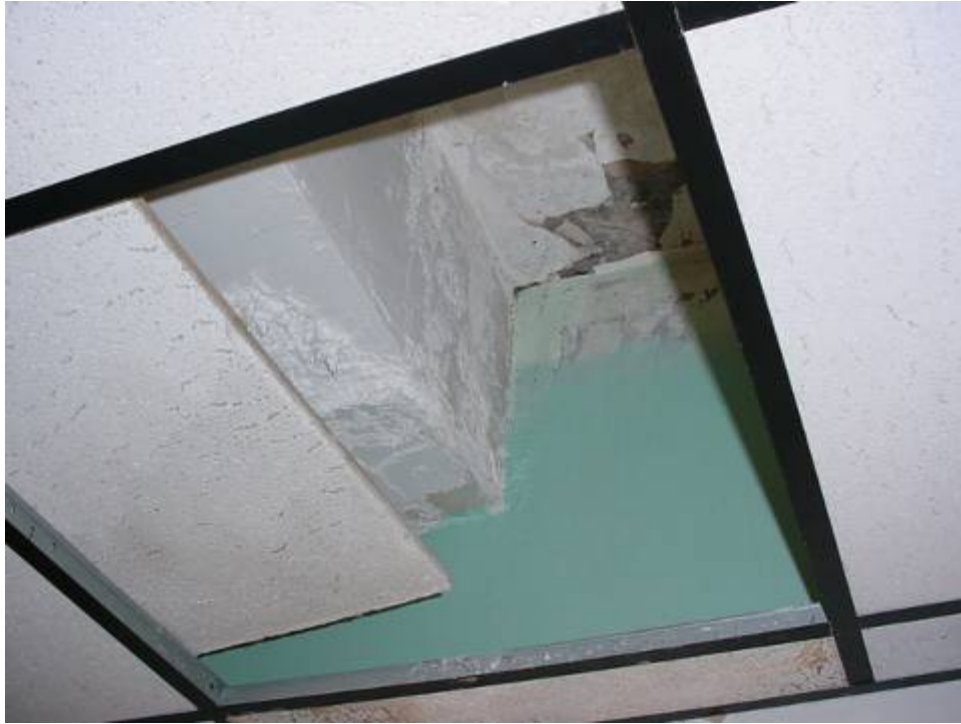
**Picture 7**

**Water Damaged Wall Plaster/Efflorescence and Peeling Paint above Ceiling Tile System**

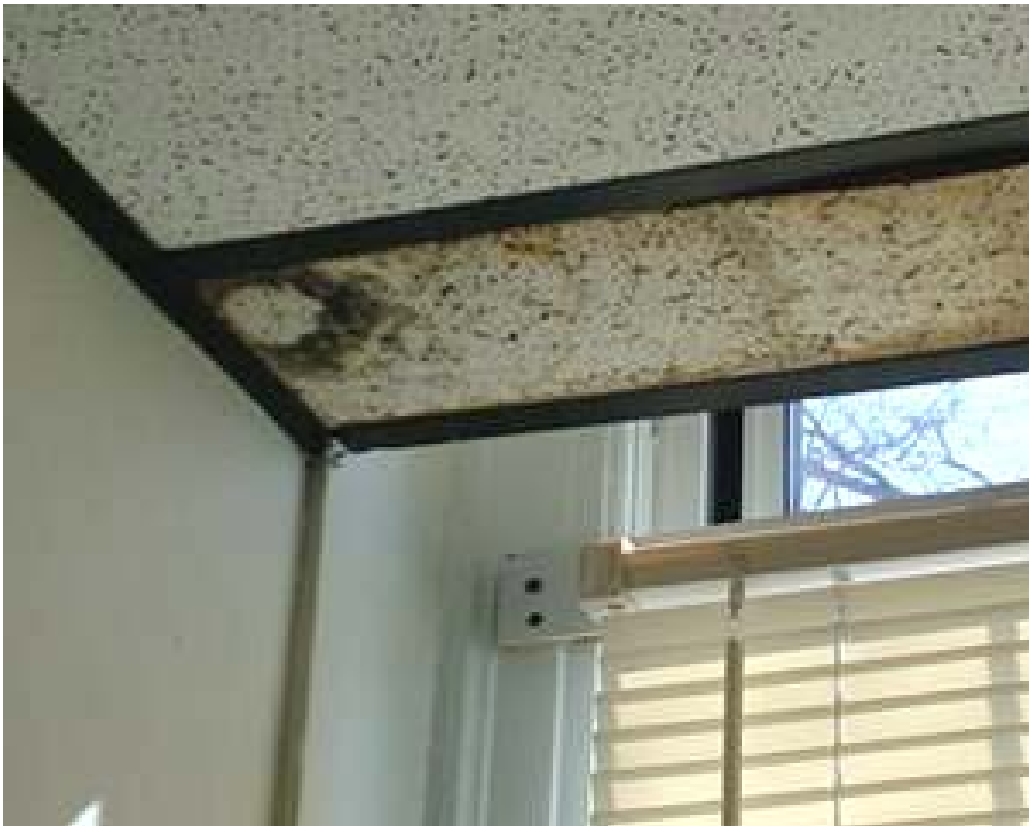
**Picture 8**

**Water Stained Ceiling Tiles, Dark Area on Left Indicates the Presence of Possible Mold Growth**

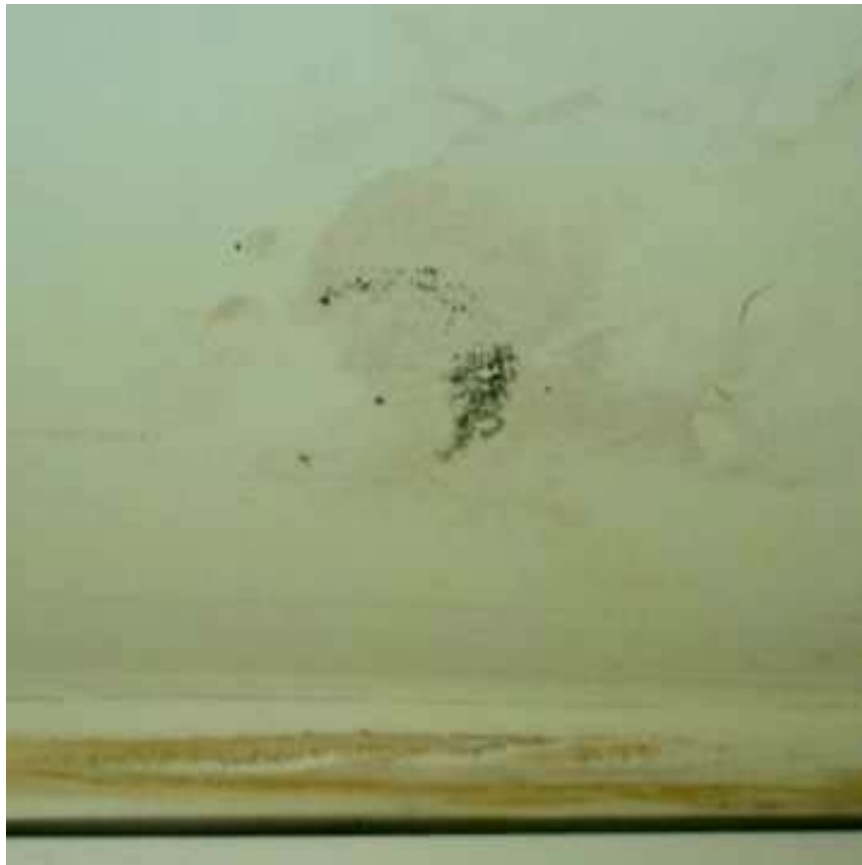
**Picture 9**

**Visible Mold Growth as Indicated by Dark Stains on GW in First Floor Office (Woolsley)**

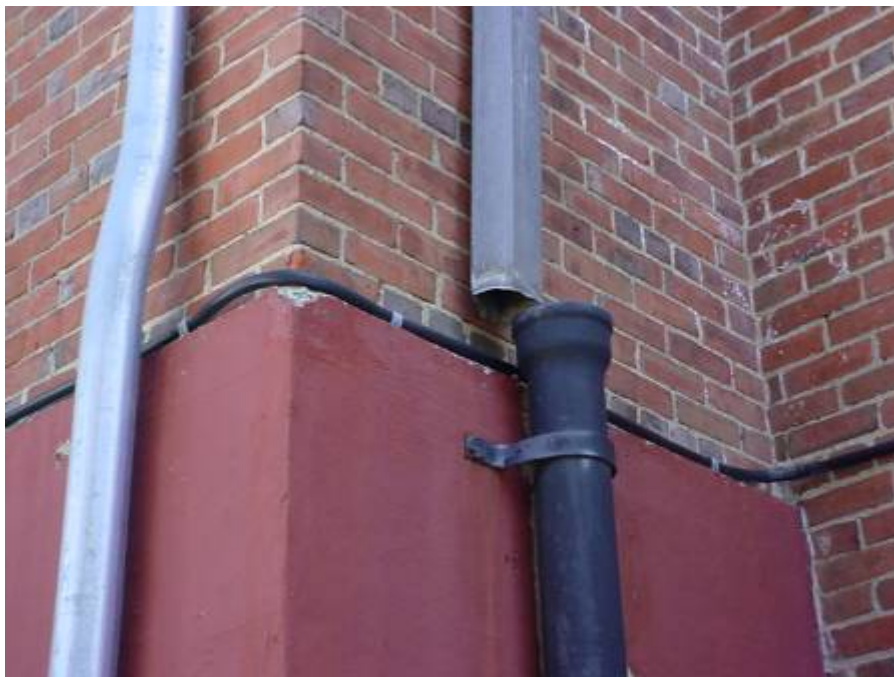
**Picture 10**

- Damaged/dislodged gutters and downspouts (Pictures 10 and 11).
- Missing/damaged mortar and cracks in exterior brick (Pictures 12 to 14).
- Missing/damaged caulking and spaces around flashing and in masonry around windows (Pictures 15 and 16).

**Disconnected Downspout and Drainage Pipe**

8. Repair/replace missing/damaged sections of gutter/downspout system.
9. Consider increasing the dust-spot efficiency of HVAC filters in modular offices (Buildings B and C). Prior to any increase of filtration, each piece of air handling equipment should be evaluated by a ventilation engineer as to whether it can maintain function with more efficient filters.

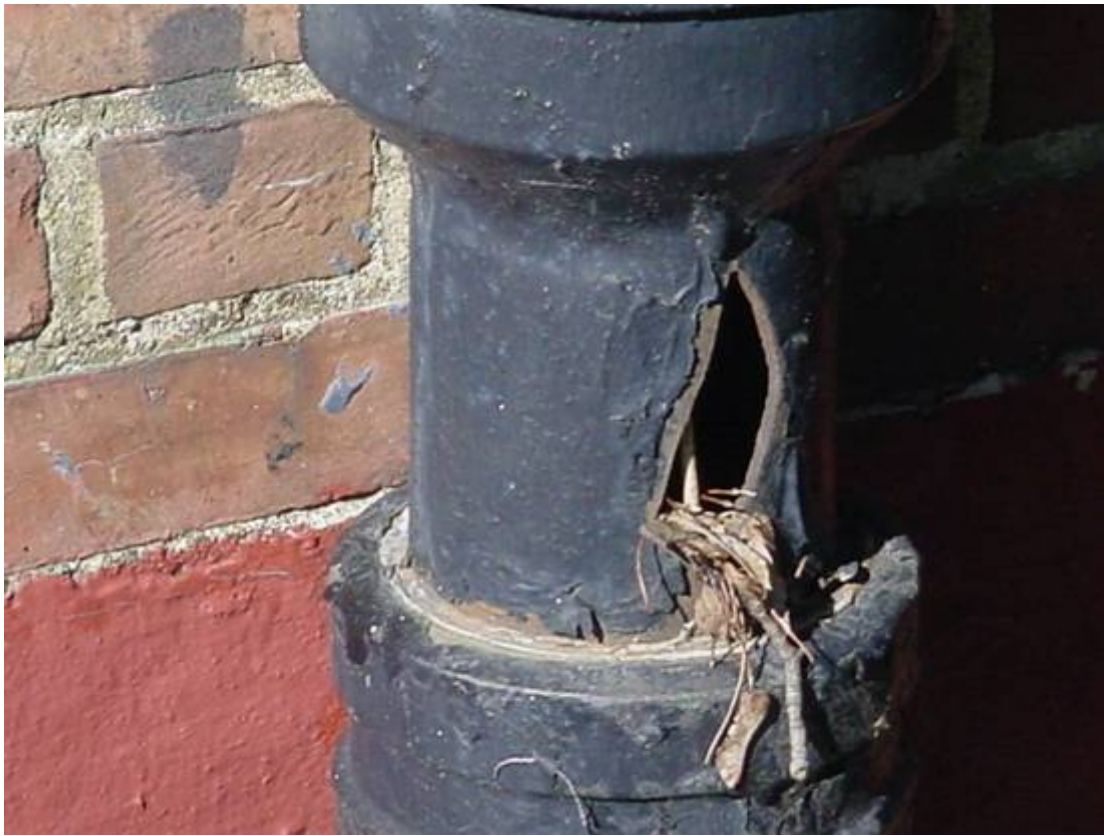
**Picture 11**

**Breach in Drainage Pipe, Note Accumulation of Material/Clog**

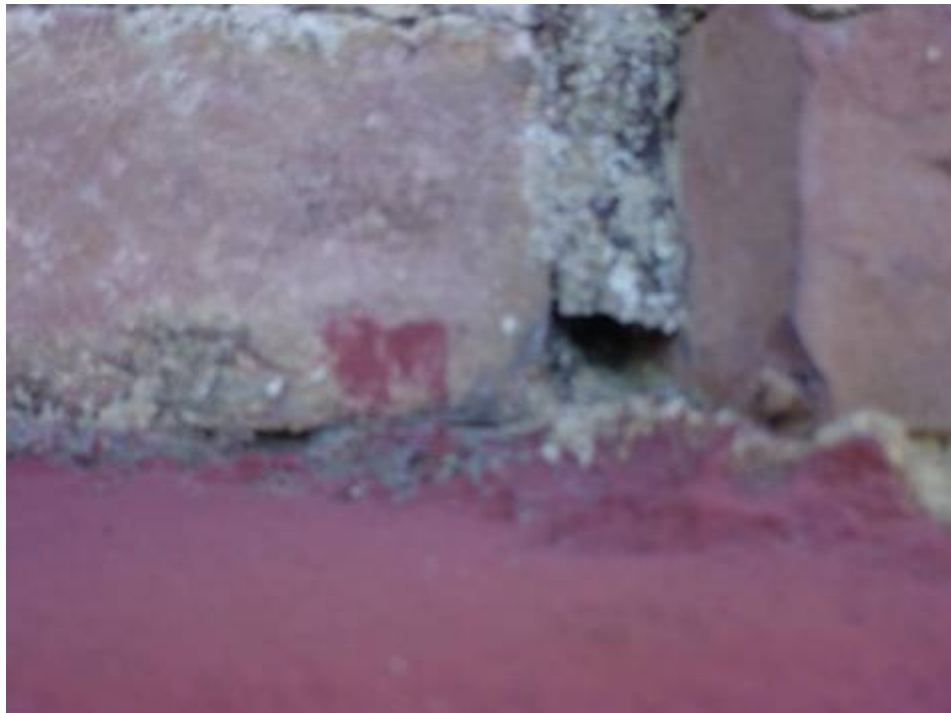
**Picture 12**

**Missing/Damaged Mortar around Exterior Brick**

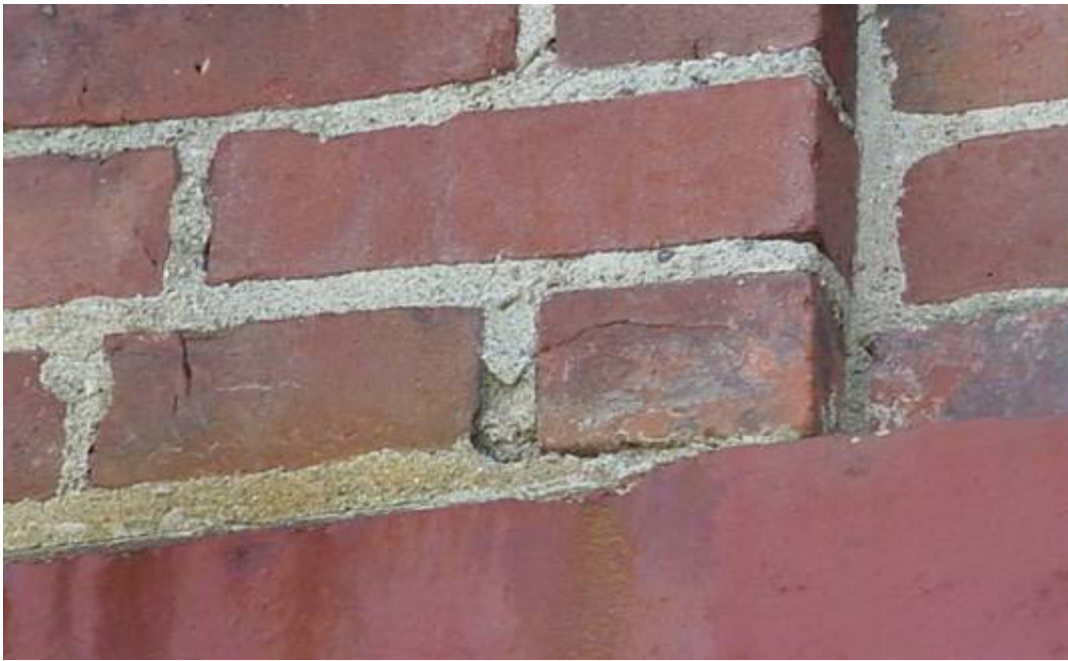
**Picture 13**

**Missing/Damaged Mortar around Exterior Brick**

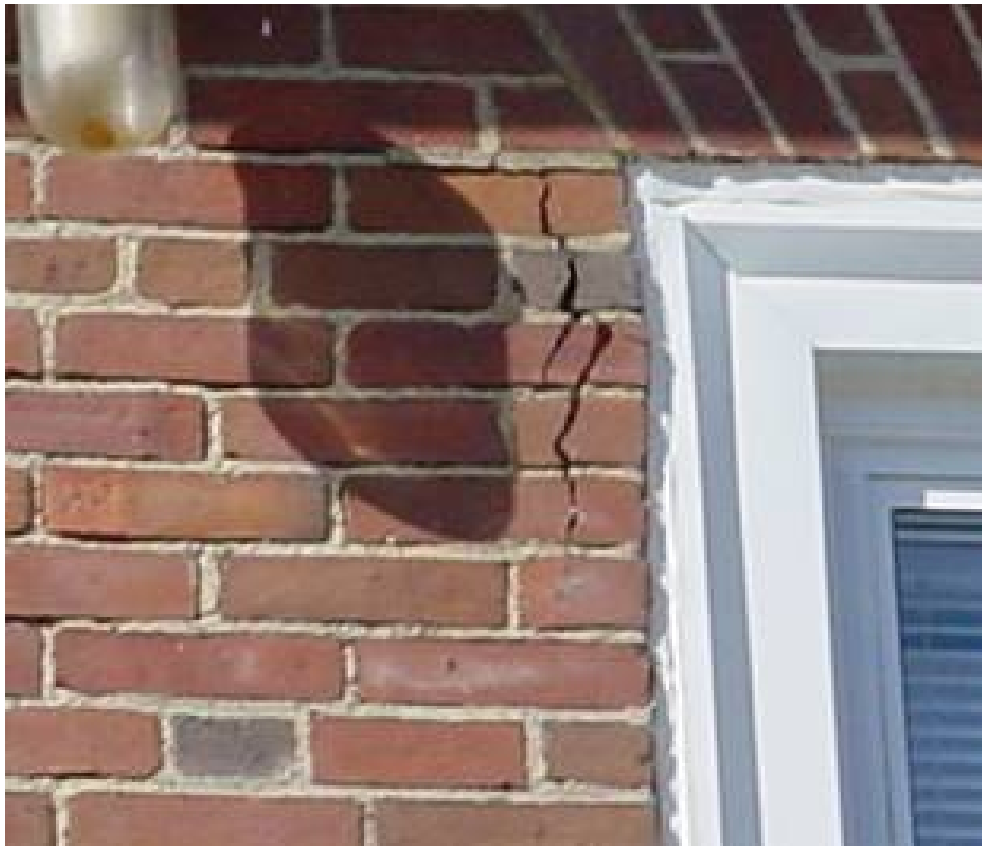
**Picture 14**

**Missing/Damaged Mortar around Exterior Brick, Note Large Fissure, Which Corresponds to Water Damaged Building Materials on the Interior**

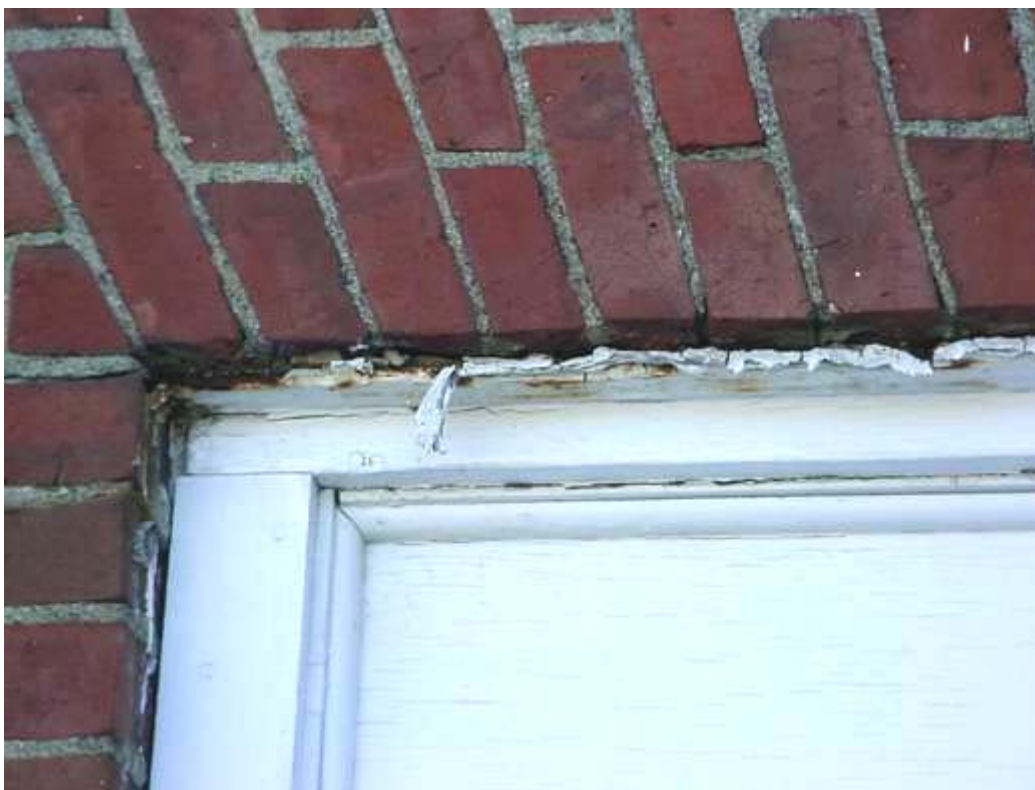
**Picture 15**

**Missing/Damaged Caulking around Window Frames**

1. Consider consulting with an architect, masonry firm or general contractor regarding the integrity of the building envelope, primarily concerning water penetration through exterior walls. Ensure all leaks are repaired.

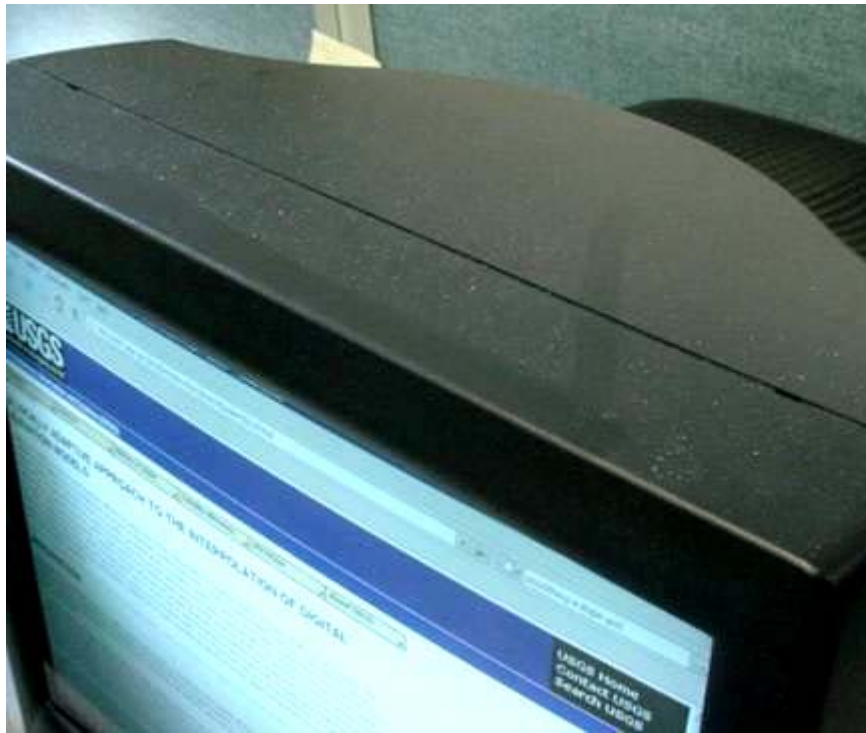
**Picture 17**

Also of note was the amount of materials stored inside offices. In areas throughout the building, items were observed on windowsills, tabletops, counters, bookcases and desks. The large number of items stored provides a source for dusts to accumulate. These items (e.g., papers, folders, boxes) make it difficult for custodial staff to clean. Several areas had cloth curtains that were water damaged, stained or had accumulated dust. Dust can be irritating to eyes, nose and respiratory tract. Items should be relocated and/or be cleaned periodically to avoid excessive dust build up. Occupants pointed out a coating of white dust on the surface of computers in Building C (Picture 17). The dust appears to have originated from the recently refinished plaster ceiling directly above work stations.

**Dust Accumulation on Surface of Computer Monitor**

10. Relocate or consider reducing the amount of materials stored in offices and common areas to allow for more thorough cleaning. Clean items regularly with a wet cloth or sponge to prevent excessive dust build-up.

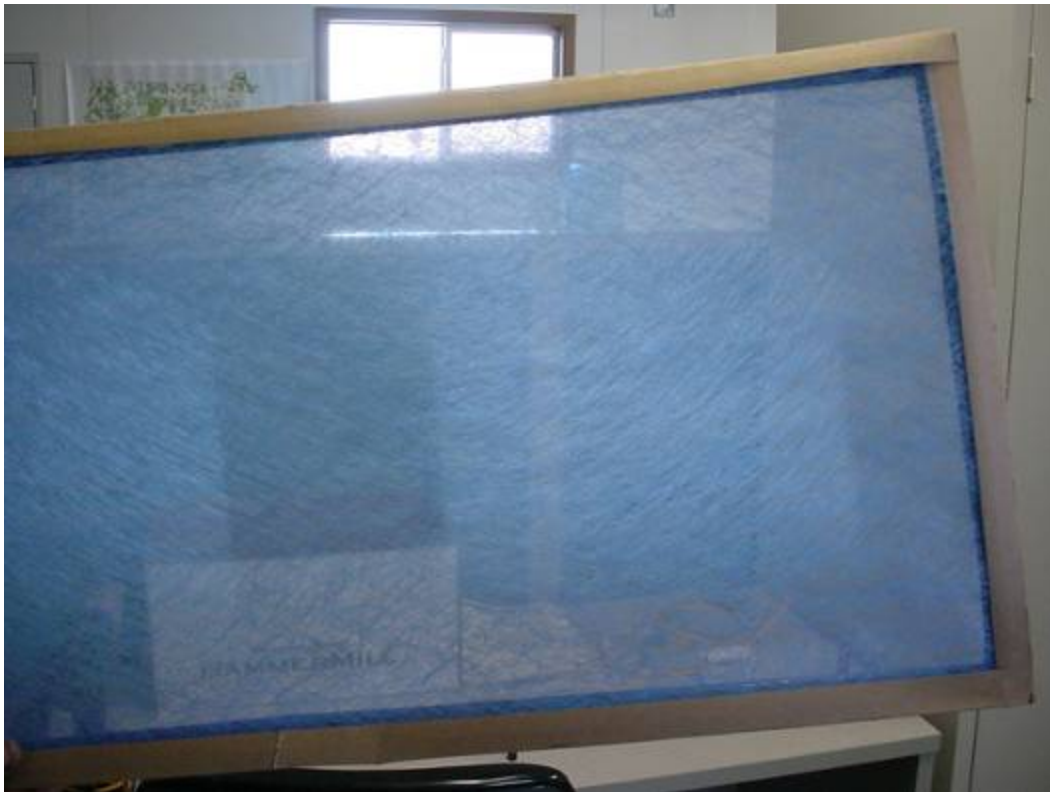
**Picture 18**

CEH staff inspected HVAC filters in the modular office buildings. The filters installed in the AHUs were of a type that provides minimal filtration (Picture 18). In order to decrease aerosolized particulates, higher efficiency, disposable filters can be installed in the AHUs. The dust spot efficiency is the ability of a filter to remove particulates of a certain diameter from air passing through the filter. Filters that have been determined by ASHRAE to meet its standard for a dust spot efficiency of a minimum of 40 percent would be sufficient to reduce airborne particulates (Thornburg, 2000; MEHRC, 1997; ASHRAE, 1992). Note that increased filtration can reduce airflow produced through increased resistance (called pressure drop), which may be occurring due to high efficiency filters installed in the central return vent, as opposed to in the AHUs. Prior to any increase in filtration, AHUs should be evaluated by a ventilation engineer to ascertain whether they can maintain function with more efficient filters.

**Fibrous Mesh Filter in Modular Office Building AHU**

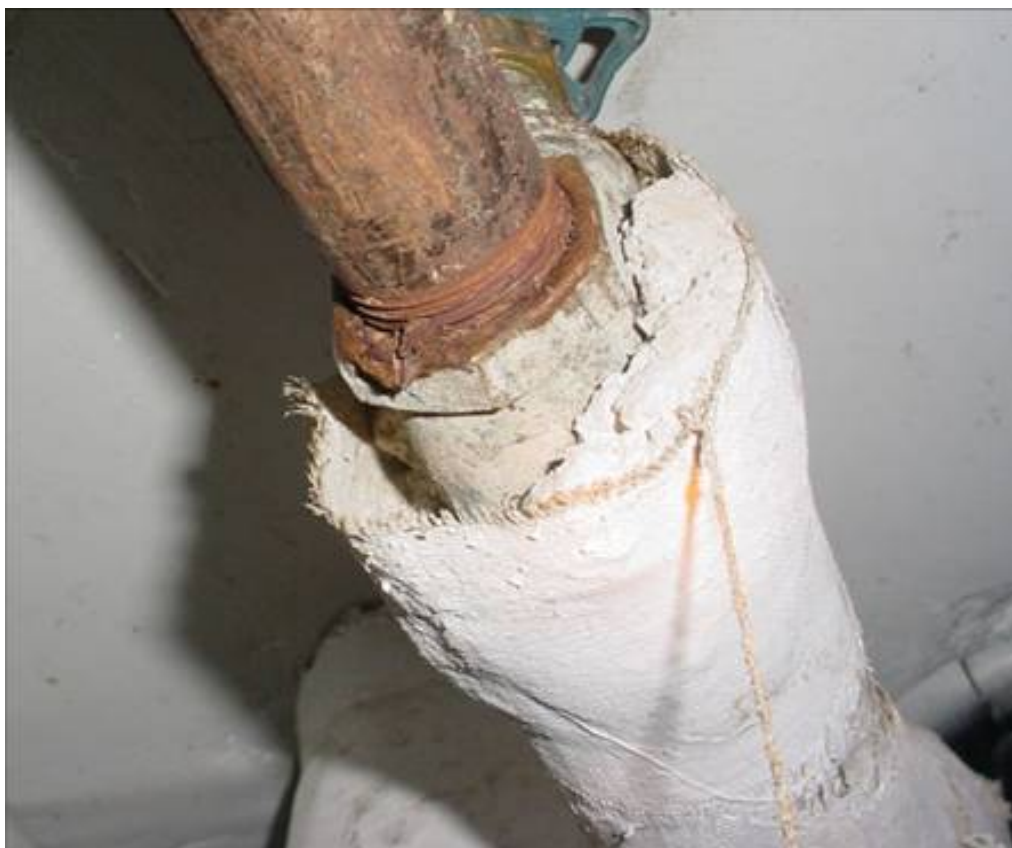
**Picture 19**

Finally, CEH staff observed exposed pipe insulation in the basement meeting room closet of Building A, which may be an asbestos containing material (ACM) (Picture 19). This finding was reported to Mr. Deblinger upon discovery. CEH staff recommended that the material be inspected/remediated by a professional remediation firm.

**Exposed Pipe Insulation in Basement Meeting Room Closet**

11. Remediate exposed pipe insulation in basement meeting room closet in conformance with Massachusetts asbestos remediation and hazardous waste disposal laws.
